Demonstration Site: Watercourse Rehabilitation

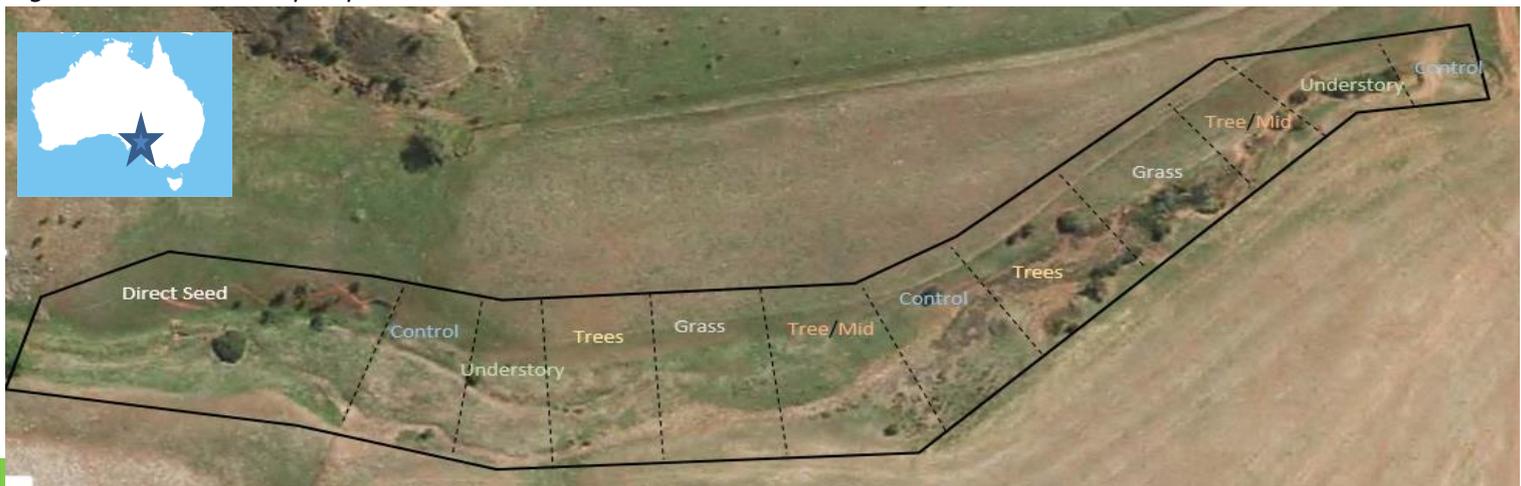
Figure 1: Rehabilitation plot plan

The site was divided into 20 metre plots of the following local plant communities, which were replicated and compared against three control areas:

- native grasses including wallaby, kangaroo and spear grass
- understory plants (approx. 60cm tall), including juncus sp., lomandra and hardenbergia
- tree's including sheoak, peppermint box and red gum
- trees and mid story plants including acacia sp., busaria and dodonae.

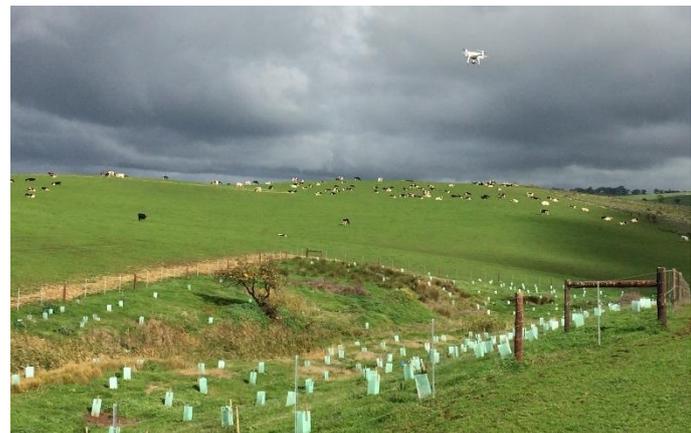
In 2016, a further 70 metres was fenced off to allow a machine direct seeding site. This was planted in August with weed and insect control at planting.

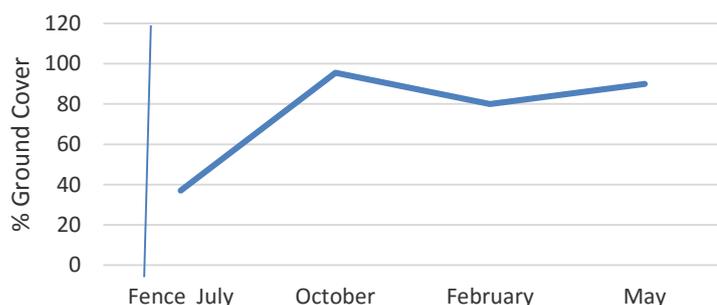
Figure 2: Ground Cover After Fence Erection 2015/16

To reduce the risk of erosion it is important to maintain ground cover levels about 80%. In 2015, prior to fencing the site and planting, groundcover levels through the centre of the watercourse measured 10-20% with areas along the bank being completely bare (Figure 2).

The most noticeable results after fencing was the reduction in pugging and the increased groundcover which only three months after the fencing were above 80% and has maintained this for the following year across the entire site. These levels significantly reduce the risk of erosion and run off, improving water quality and demonstrate the effectiveness of simply removing stock from the watercourse area.

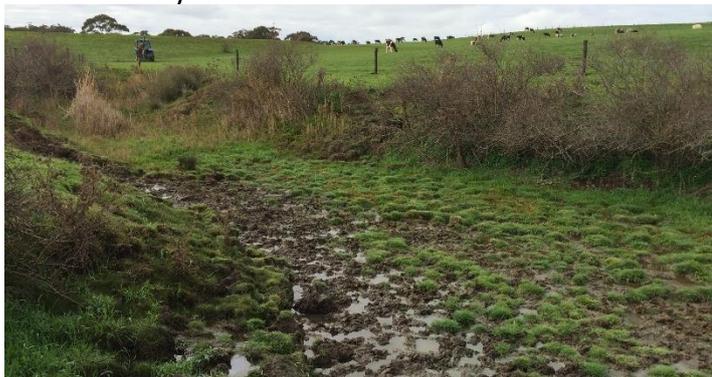
Figure 3: June 2015- Prior to Rehabilitation

In June 2015, fencing occurred along a 250m length of watercourse which runs during the winter months and was significantly pugged throughout the year.
