BIGG Soil Moisture Report – 12/11/20 Flaxman Valley, Keyneton, Koonunga, Moculta

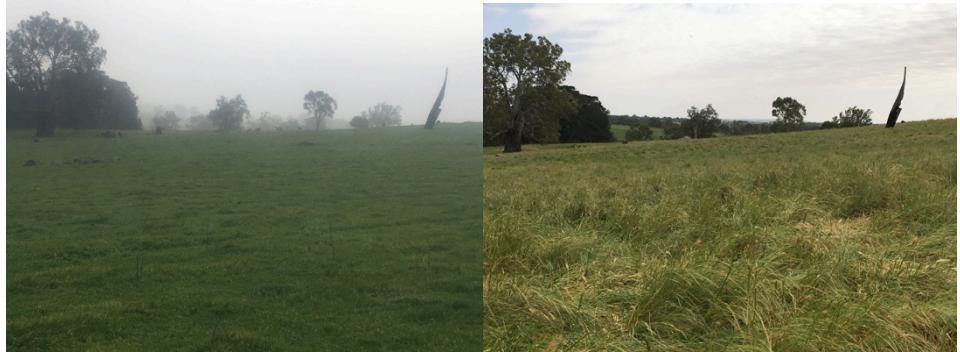
Flaxman Valley (Evans)

Photo of weather station paddocks – 23/6/20 (left) and 11/11/20 (right)

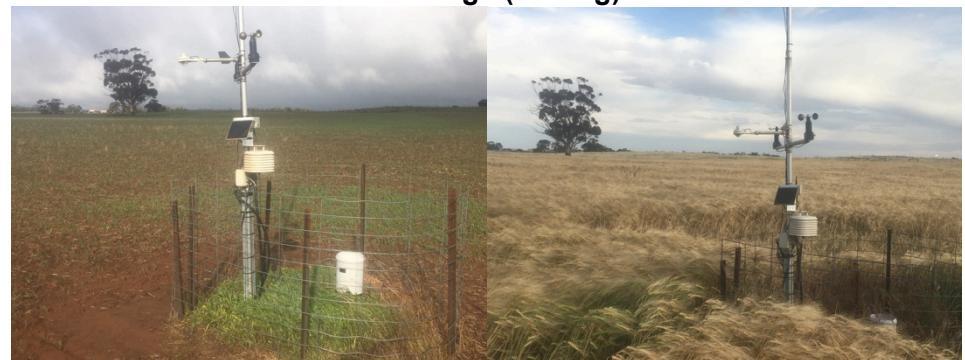
Koonunga (Kleinig)

25.000 mm water - 0.000 mm water - 0.0000 mm water - 0.00000 mm water - 0.0000000000000000000000000000000000	
2020 rainfall	401mm Estimated soil moisture _	
(Apr-current)	in the profile	
Soil type	Red brown earth	
Pasture/crop	Barley (sown in 2020)	
Current pasture	Composition: Barley plants 100%	
status (see photos below)	Estimated Feed on Offer: -	
2020 paddock and grazing management	Compass barley was sown on 26/5/20 with the paddock to be rept in December (expected yield 4.0t/ha). The paddock has not been grazed all season.	
Narrative	The PAW graph above paint a different picture to what the Koonunga soil probe is currently reading. Growing season rain is over 400mm compared to 230mm at this time last year however the probes are only showing 8% remaining moisture. What has caused this discrepancy?	
	The answer lies in an event that occurred in September, when the crop immediately around the probe site was laid down by strong winds. As a result, instead of infiltrating evenly, rain was running off, leaving the soil around the probe dry. This provides a good lesson in why we must be vigilant in ensuring that the probe site stays representative. If the probe were 2m further away, it would have shown a completely different and more realistic picture.

The best way to get a feel for what moisture levels across the paddock are really like would be to take out an auger or spade and dig up some soil samples so they can be assessed by hand. If the other sites are a guide, the profile is probably at 30 to 50% capacity.

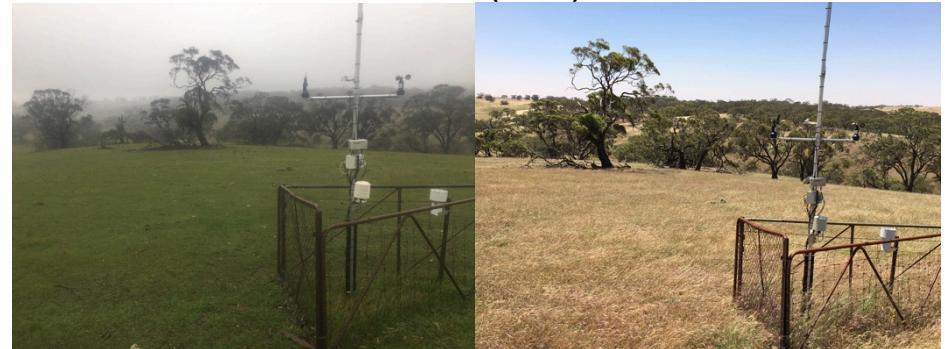
Moculta (Koch)

50.000 mm water -	
	25.00 mm vater -	
2020 rainfall	1/01/20 1/07/20 1/07/20 1/10/20	
(Apr-current)	in the profile	
Soil type	Shallow clayey red brown earth over lime	
Pasture type	Native pasture	
Current pasture status (see photos	Composition: Annual/native grasses 35%, Capeweed 10%, Dry surface little 55%	
2020 paddock and grazing management	Over the last few months a mob of 400 ewes have been rotated through the paddock on a monthly basis for a period of 5-6 days (stocking rate 8 DSE/ha). On 5/11/12, 82 ewes were moved into the paddock where they will be set stocked until the end of December for mating.	
Narrative	In 2019 we set the estimate of PAW at the Moculta site to 35mm but this year have been able to lift it to 55mm. Available moisture has been above 2019 levels all season and the profile is at close to 50% capacity compared to 16% at the same time last year.	
	Bear in mind that even with this year's rains we have not seen the profile fill completely. We use changes in the separate level graph to indicate when the profile is full: as moisture at a level reaches saturation and starts to flatten out, any extra moisture received as rain drains quickly through the profile and is visible as a rapid increase in moisture on the next sensor down.

Last year we only really saw moisture increase down to 45cm whereas this year we have seen it get to 65cm. There is an added complication here in that the site is quite steep, so some water is always going to be lost to runoff down the slope - both at the surface and above any restrictive layers in the soil.
