## Harvesting rainwater proves invaluable during dry times

LOCATION: Robertstown

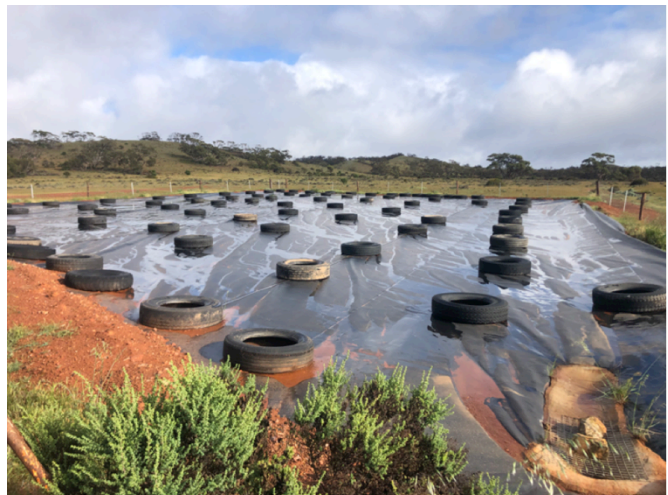
**The lined catchment situated immediately above an existing dam on Dale's property**

After receiving only 142mm of rainfall in 2017, Dale 'bit the bullet' in February 2018 and constructed the lined catchment. The catchment area was 1,200m<sup>2</sup> (30x 40m) and located on a slight slope immediately above an existing dam, which holds really well.

Earthworks were initially conducted to flatten and shape the catchment area, including cleaning out the dam. Eight-metre wide poly-liner was then laid over the area (secured by truck tyres) and welded together. A cement drain pit was then installed (at the catchments lowest point), along with storm water pipe to enable the flow of water from the catchment into the dams existing cement causeway. Finally, a 1.2m high cyclone fence was erected around the catchment area to keep stock and wildlife out. All up the project cost \$11,800:

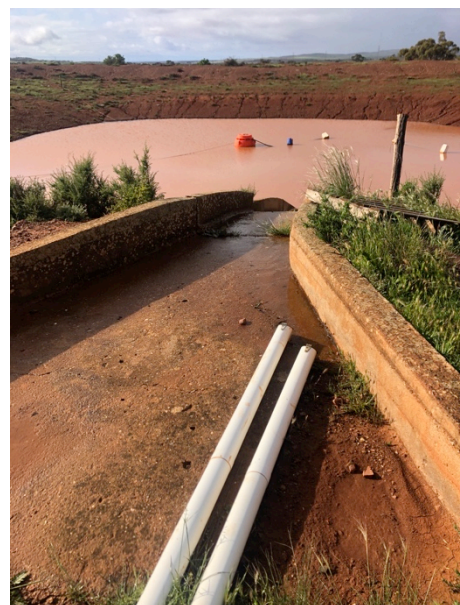
**Storm water pipe enabling water flow into the dam causeway from the lined catchment**
